**JACEK CZECHOWICZ**

# ROZBUDOWA KOŚCIOŁA KARMELITÓW BOSYCH W KRAKOWIE W LATACH 1929–1933 WEDŁUG ÓWCZESNEGO DZIENNIKA PRAC BUDOWLANYCH

## EXTENSION OF THE CHURCH OF THE DISCALCED CARMELITES IN KRAKOW IN THE YEARS 1929–1933 ACCORDING TO ITS CONSTRUCTION LOG FROM THAT PERIOD

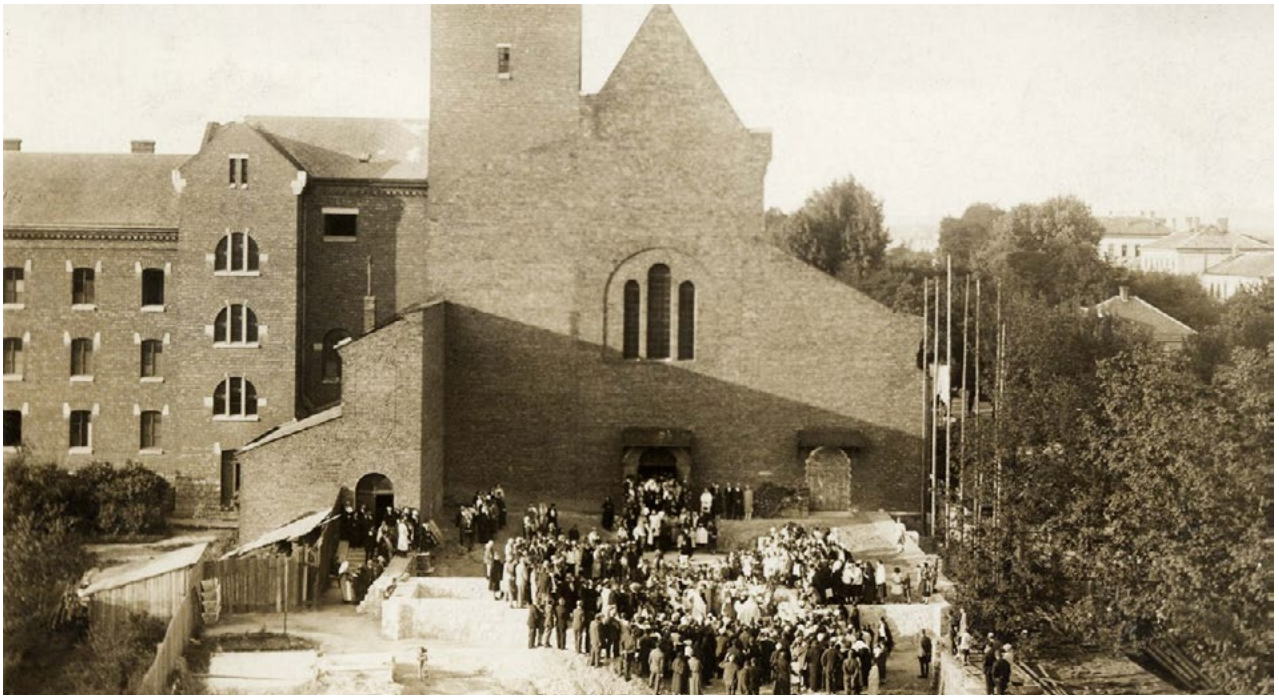
Il. 2. Zdjęcie z uroczystości wmurowania i poświęcenia kamienia węgielnego, 15.08.1929, Archiwum Krakowskiej Prowincji OCD, zdjęcia

Ill. 2. Photograph of the laying and consecration of the cornerstone, 15.08.1929, Archive of the Krakow Province of the OCD, photographs

A photograph documenting the celebration, taken late in the afternoon, probably from the uppermost storey of a townhouse located on the other side of the street, near the corner of Lubomirskiego and Rakowicka streets, depicts the construction site being surrounded by a wooden fence. There is a clear outline of the base walls of the nave section. Inside the level of the terrain appears to be slightly raised—from the south. From the west there are visible foundations prepared for the pillars of the aisle, touching the eastern wall of the gatehouse. The construction site was arranged in a model manner—on the left side we can see neatly stacked boards and nearby—baskets for the moving of construction materials, while to the right there are bricks laid out in cuboid blocks, with timber shores beside them. Along the eastern wall we can see a row of tall, vertical columns for the scaffolding, at a distance of 1,8 m from the wall and spaced around 3 metres away from each other. The entrance to the chapel of Holy Mary of the Sharp Gate appears to be walled off, while the entrance at the axis of the presbytery was still in use (ill. 2).

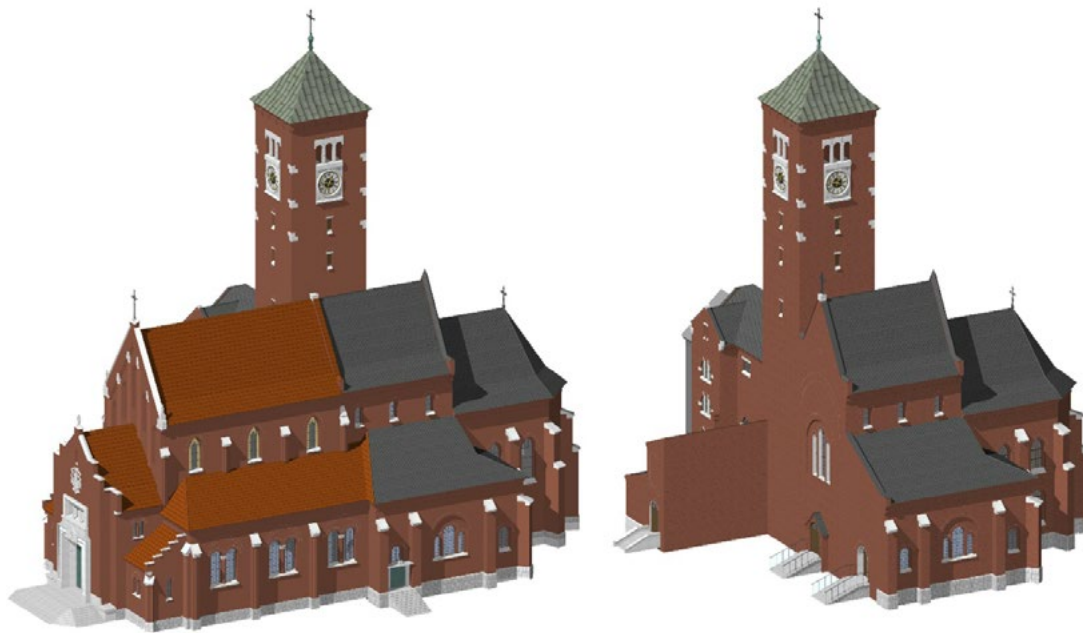
Il. 4. Kraków, kościół Niepokalanego Poczęcia NMP. Z prawej: faza I, 1908–1910, z lewej: faza II, 1929–1933, rys. autor

Ill. 4. Krakow, Church of the Immaculate Conception of Virgin Mary. To the right: phase I, 1908–1910, to the left: phase II, 1929–1933, drawn by author
