TEKA KOMISJI URBANISTYKI I ARCHITEKTURY
O/PAN W KRAKOWIE
URBANISM AND ARCHITECTURE FILES
OF THE POLISH ACADEMY OF SCIENCES
KRAKÓW BRANCH
TOM LIII/2025 PL e-ISSN 2450-0038
pp. 433–450 PL ISSN 0079-3450
DOI: <https://doi.org/10.24425/tkuia.2025.157385>

ANDRZEJ LEGENDZIEWICZ

TRANSFORMATIONS OF THE MEDIEVAL ARCHITECTURE OF THE PARISH CHURCH IN ZŁOTY STOK AGAINST THE BACKGROUND OF STYLISTIC TRENDS OF THE GOTHIC AND RENAISSANCE PERIODS IN SILESIA

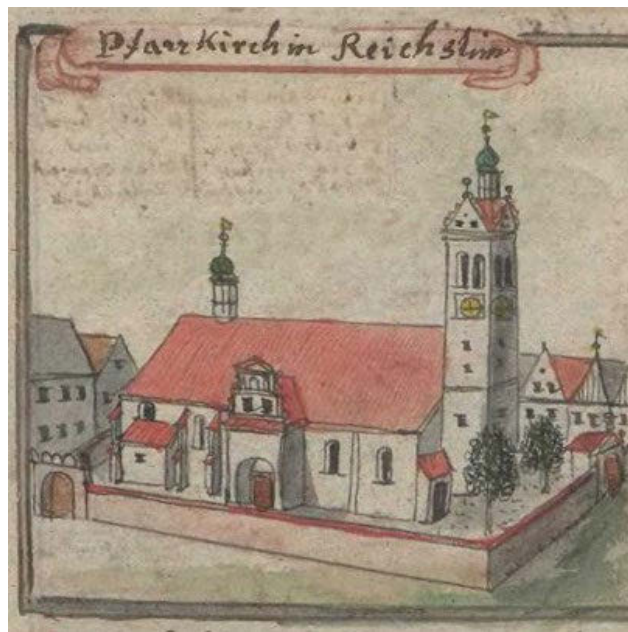
Ill 3. Złoty Stok, former Corpus Christi church, general view from the north-west in the mid-18th century according to F.B. Werner.

The renaissance layout of the roofs, attic, and the gable wall over the rainbow arcade were changed. Instead, a gable roof, known from Fryderyk B. Werner's illustrations, was introduced over the nave and the chancel. From the west it was limited by a triangular gable contoured by the so-called 'cat's steps' (a kind of brick cornice, which crowned the steep, medieval gables of houses). A small fleche was placed on the ridge.

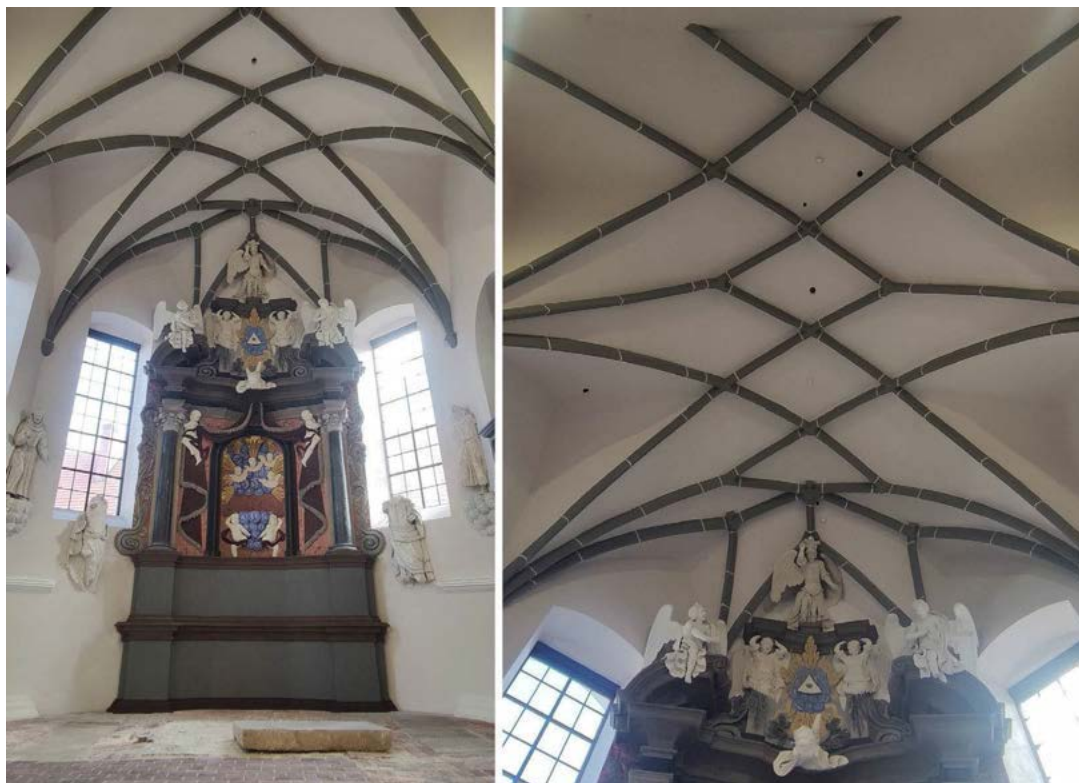
Ill. 6. Złoty Stok, former Corpus Christi church, chancel a) interior; b) vault. Photos by the Authors.

The interior of the chancel was covered with a barrel vault with lunettes. Its decoration was made of net ribs arranged in the so-called cathedral system (with

a double duct). In the altar part, there are now three broken ribs that emerge from bosses with shields.

The largest boss, which connects the five ribs above the altar's mensa, is decorated with a representation of the Silesian eagle. The *tas-de-charges* of the stone ribs, which have a double-cavity profile, are based on stone corbels with heraldic cartouches. From the west, the chancel probably opened onto the nave through a ogival chancel arcade — traces of which in the form of an arch made of *voussoir* were found above the present arcade during the performed excavations. The rainbow arcade was supported by a pair of pillars that reached the corners of the present nave. From these corners, brick toothings were formed towards the west to connect the perimeter walls of the nave. In the foundation part of the building, in the north-eastern corner of the nave, the foundation of a diagonal pillar was found. This relic indicates that the original intention was probably to build a vaulted nave.

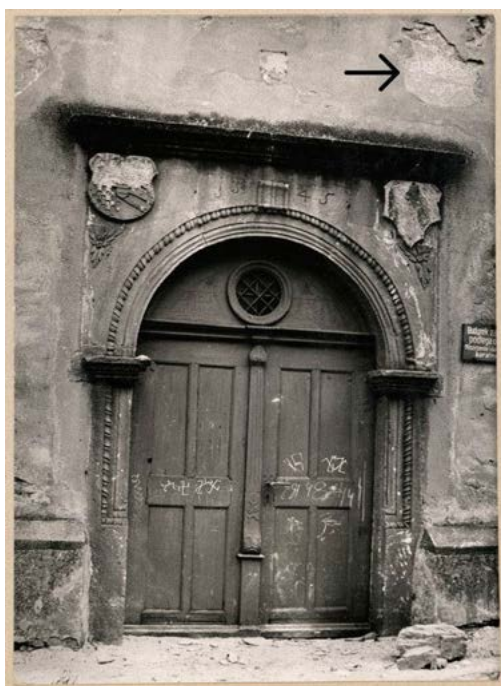
Ill. 7. Złoty Stok, former Corpus Christi church, western portal with visible relic of sgraffito.

The main entrance is located on the ground floor of the west facade of the tower, and is enclosed in a stone Renaissance portal. Its composition consists of pillars with capitals, on which the semicircular arcade with a keystone is located. The frames have a fascia decoration that includes a braided motif and spandrels decorated with coats of arms and flowers. The date 1545 was carved on both sides of the keystone, and a profiled cornice was placed above it. The southern entrance to the nave is preceded by a porch, in which there is the original entrance to the nave — enclosed by a deeply profiled, two-framed gothic portal.

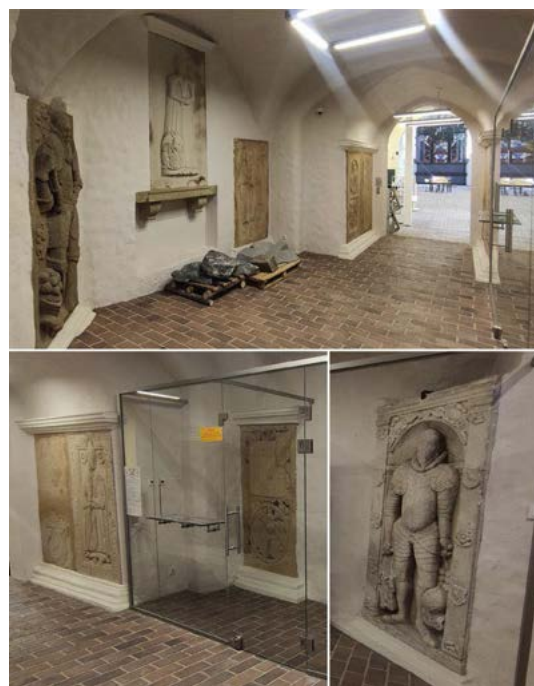
Ill. 8. Złoty Stok, former Corpus Christi church, vestibule. Photo by the Authors.

The ground floor of the tower is filled with a porch that is covered with a groin vault with triangular profiles at the intersection of the barrel vaults. The canopy of the first level has a similar decoration. The subsequent five levels are distinguished by massive ceilings, which were probably installed in place of older wooden ones. Access between them is provided by spiral stairs located on the axis of the eastern facade of the tower, which is accessible from the north.

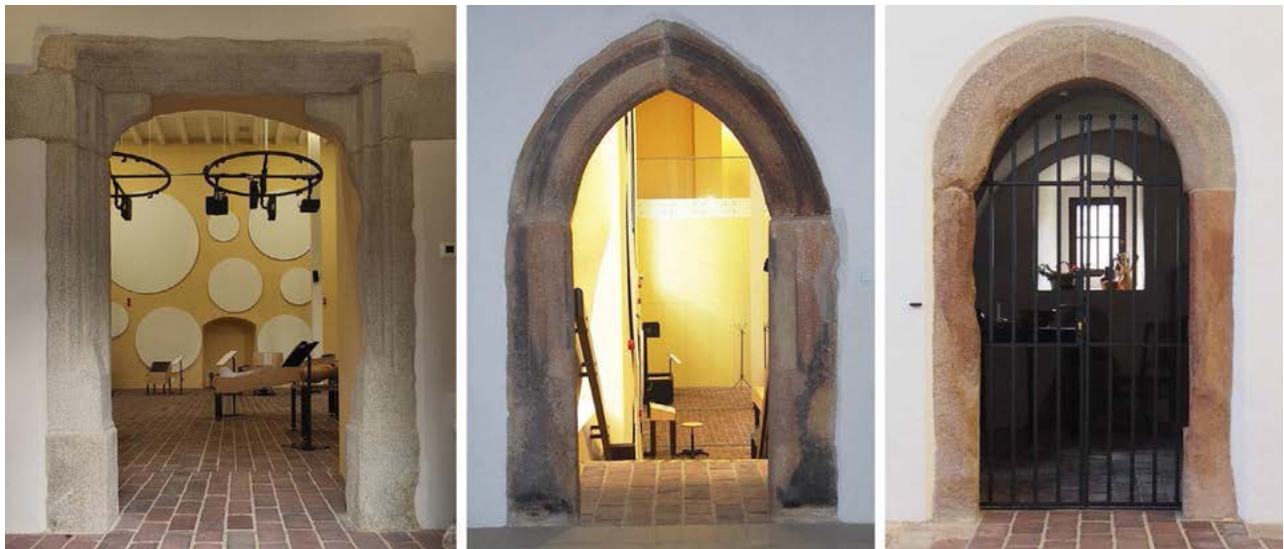
III. 9. Złoty Stok, former Corpus Christi church, portals: a) in the south porch; b) in the lodge; c) in the sacristy. Photo by the Authors.
 II. 9. Złoty Stok, dawny kościół pw. Bożego Ciała, portale: a) w kruchcie południowej, b) w loży, c) do zakrystii. Fot. Autorzy.

On the southern side of the chancel, at the height of the rectangular bays, a one-story sacristy with dimensions of 9.4 m by 4.8 m in its outer contour was erected. It was covered with a double-span barrel vault with two lunettes. Interior lighting was provided by small, narrow windows: two from the south in the spans' axes, and one in the eastern wall. A small semi-circular recess was located under the western opening in the southern wall, and next to it there was a lavabo. In the western wall, a wide sectional recess was built during the construction of the perimeter walls. The entrance to the sacristy from the chancel side was placed in the western bay and surrounded by a stone ogival frame with a bevel.

(Neuling, 1902, pp. 255). This dating can also be confirmed by the form of the architectural details of the entrance portal to the patron's lodge, where there are intersecting jambs of profiles.
